HERITAGE ASSESSMENT

Sydenham to Bankstown Urban Renewal Corridor
Heritage Review – Supplementary Review

20 May 2017

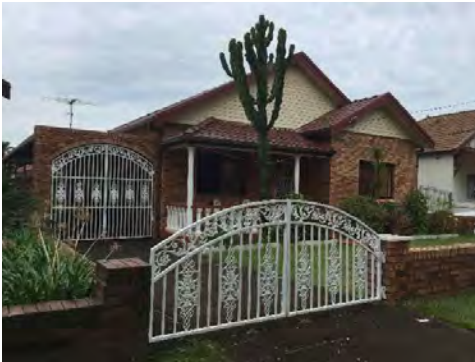
Figure 30 – Modified example of a Pre WW1 dwelling in Acacia Street

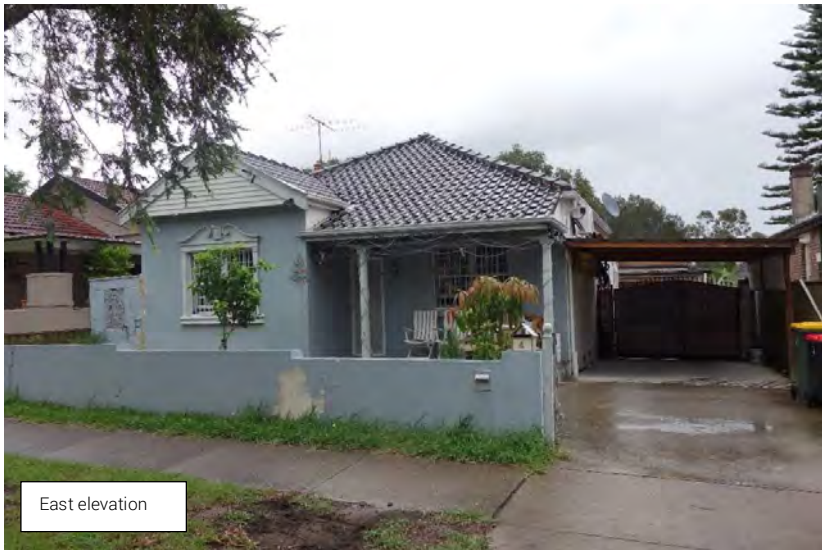
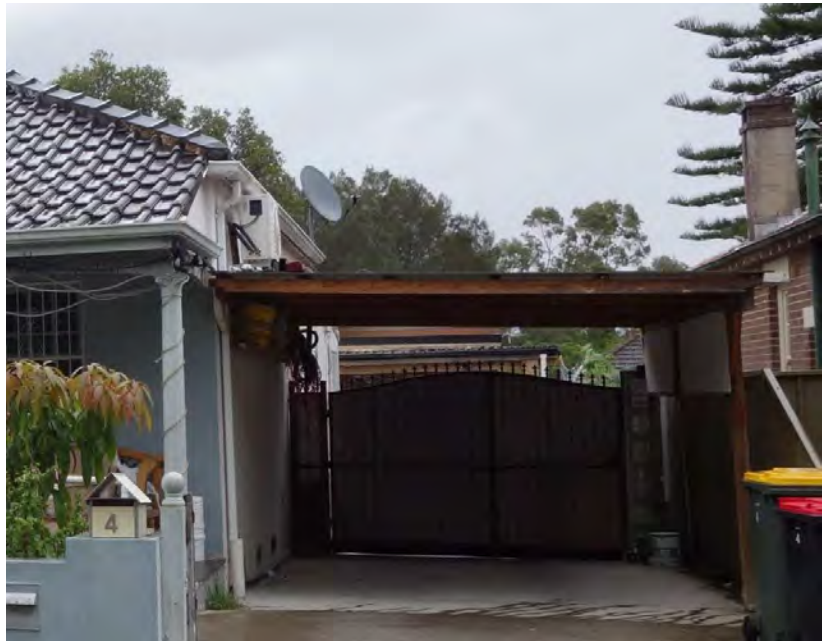
4 Cleary Avenue, Belmore

Description	Dwelling located on the western side of Cleary Avenue. Front façade faces east.
Modifications	<ul style="list-style-type: none"> • Front façade has been heavily modified; • Carport and new paving; • Fibre cement sheeting lean to extension at the rear; • Gable end detail has been concealed by timber panels; • Awning along the east façade has been removed. •

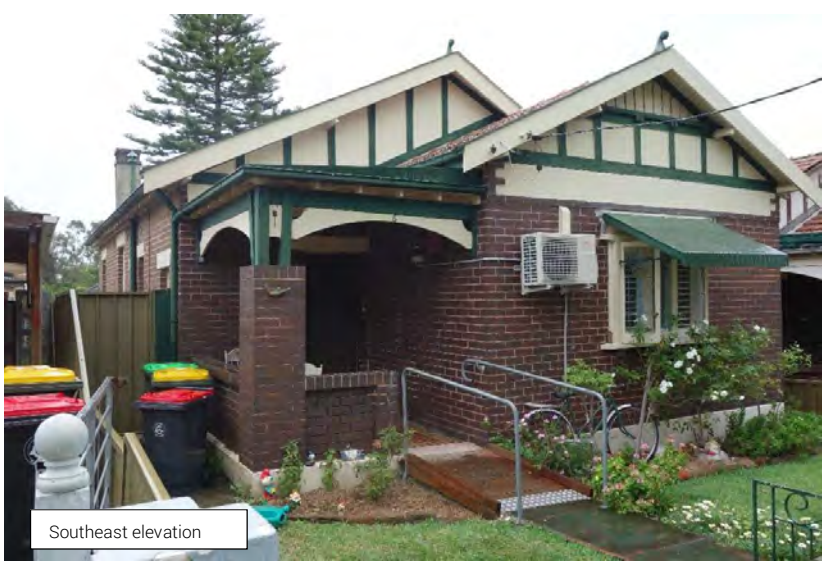
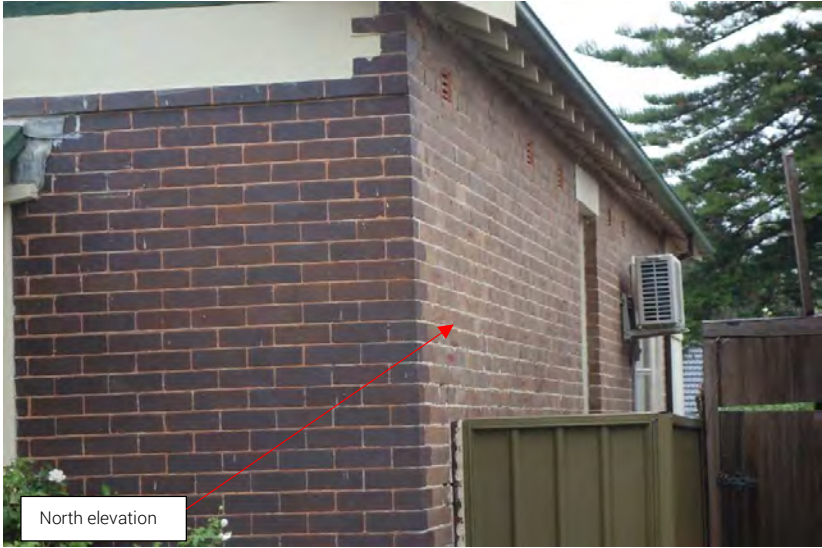
6 Cleary Avenue, Belmore

Description	Dwelling located on the western side of Cleary Avenue. Front façade faces east.
Modifications	<ul style="list-style-type: none"> • Air-con units along the east and north elevation. • Paving of the front garden.

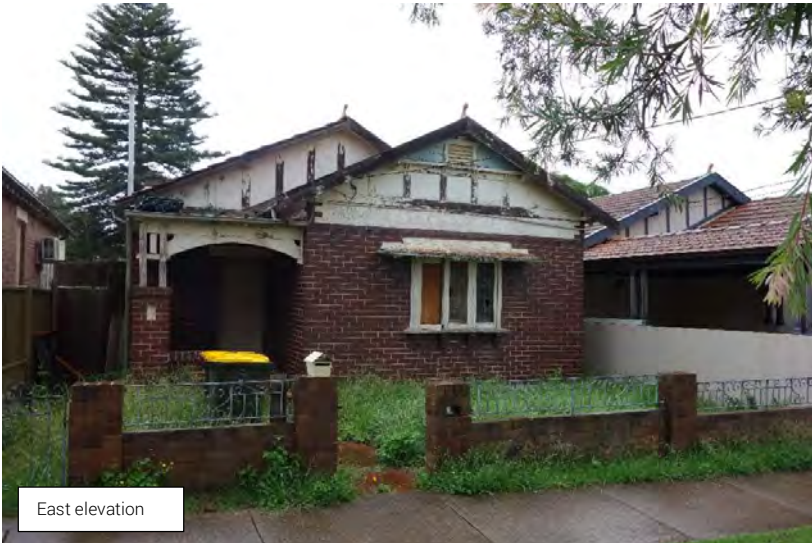
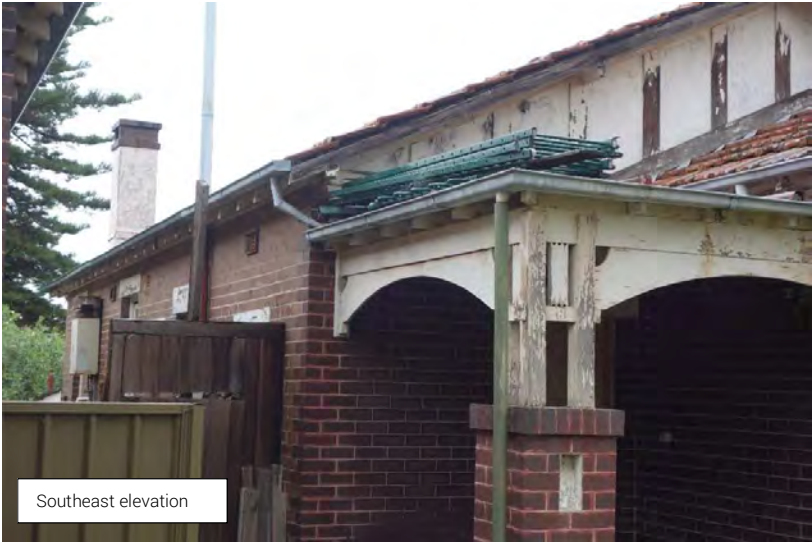
8 Cleary Avenue, Belmore

<p>Description</p>	<p>Dwelling located on the western side of Cleary Avenue. Front façade faces east. This building is in poor condition.</p>
<p>Modifications</p>	<p>---</p>

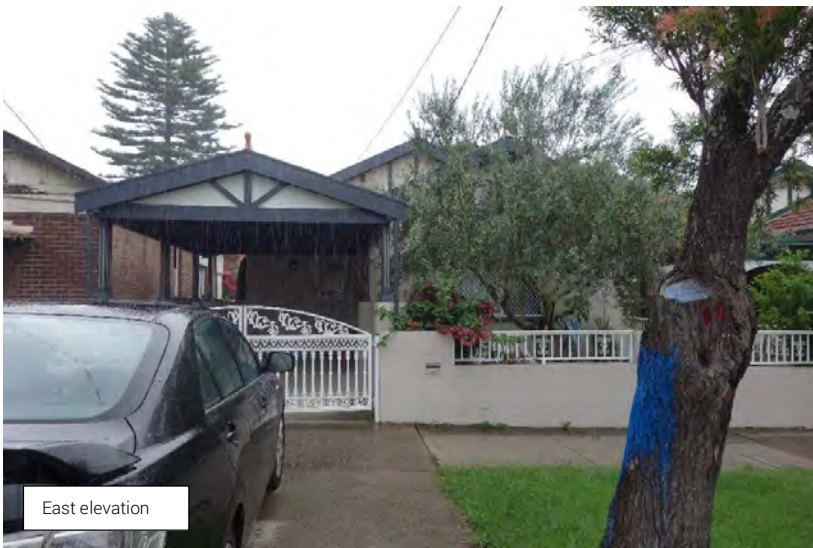
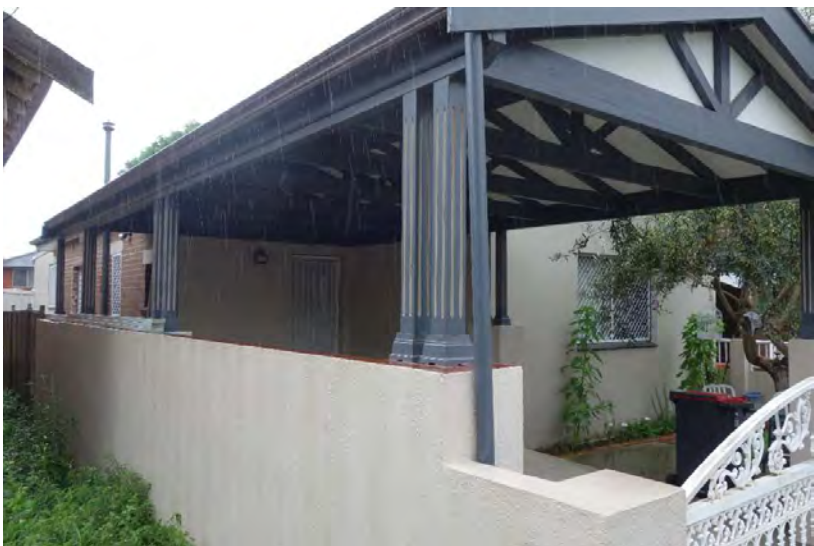
10 Cleary Avenue, Belmore

Description	Dwelling located on the western side of Cleary Avenue. Front façade faces east.
Modifications	<ul style="list-style-type: none"> • Lean to fibre cement sheeting extension at the rear; • Carport; • Front façade has been heavily modified; • Windows along the east elevation have been replaced.

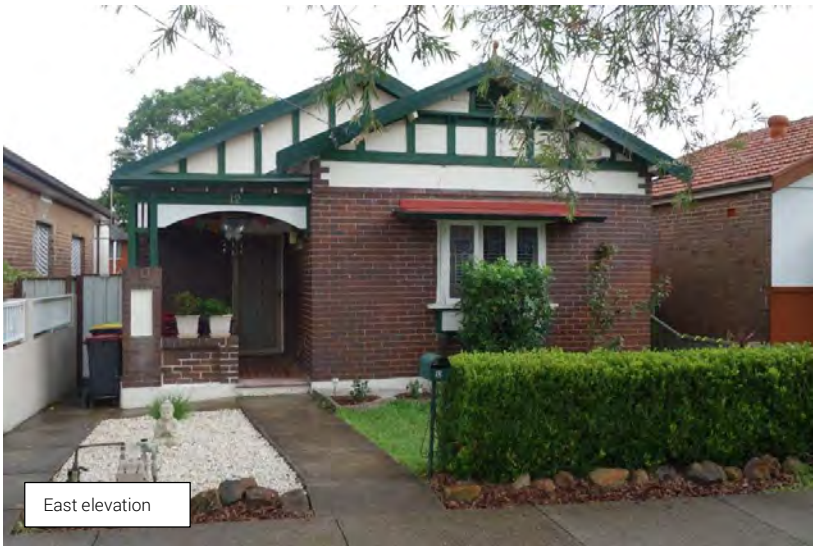
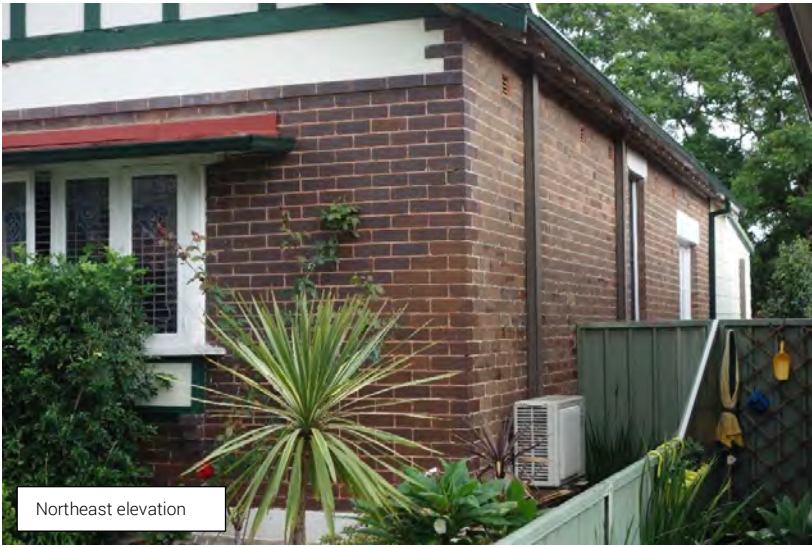
12 Cleary Avenue, Belmore

Description	Dwelling located on the western side of Cleary Avenue. Front façade faces east.
Modifications	<ul style="list-style-type: none"> • Garden wall has been removed and replaced with hedging; • Air-con unit along the north elevation; • Weatherboard extension at the rear; • Awning has been replaced along the east elevation.

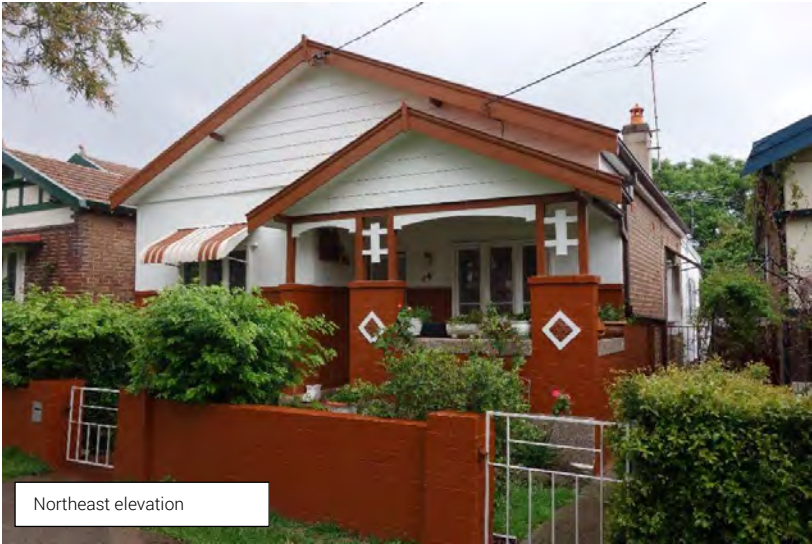
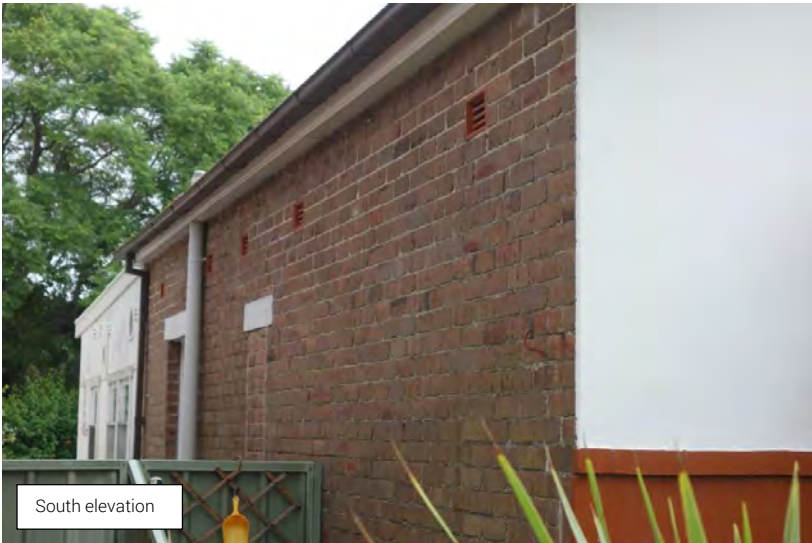
14 Cleary Avenue, Belmore

<p>Description</p>	<p>Dwelling located on the western side of Cleary Avenue. Front façade faces east.</p>
<p>Modifications</p>	<ul style="list-style-type: none"> • Infilled window along the south elevation; • Fibre cement sheeting lean to extension at the rear; • Awnings along the north and east elevation have been replaced; • Gable end details have been concealed by timber panels.

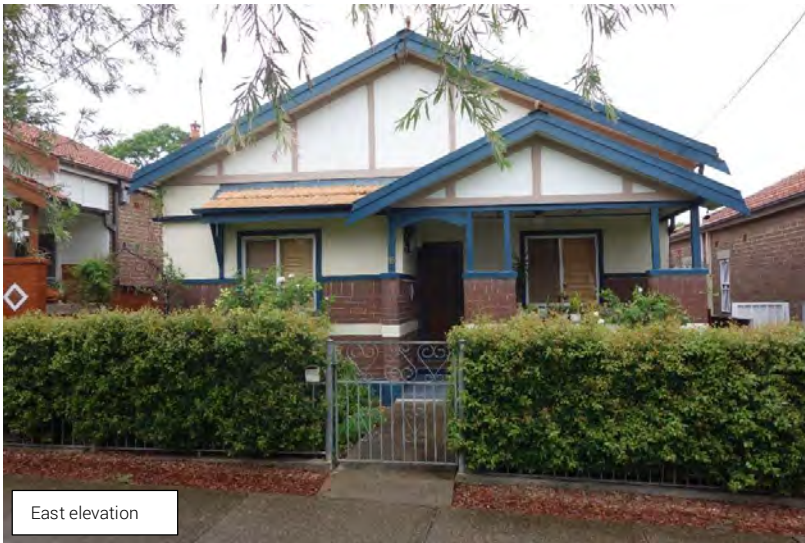
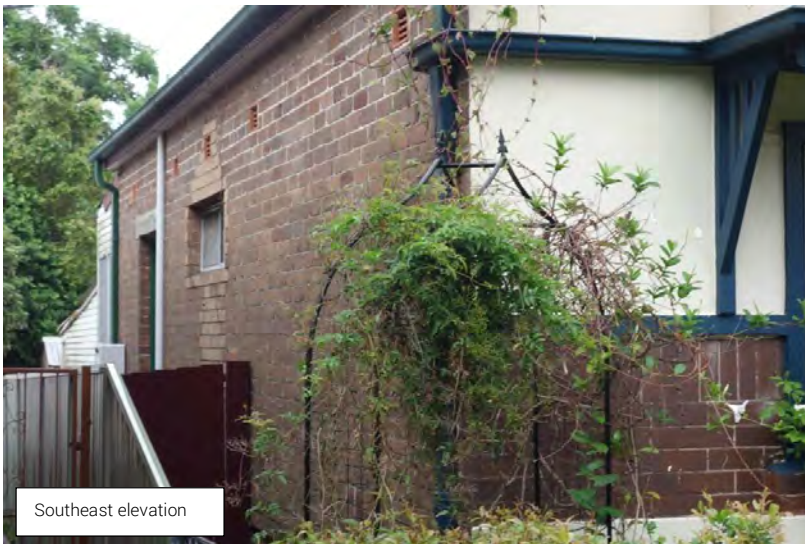
16 Cleary Avenue, Belmore

Description	Dwelling located on the western side of Cleary Avenue. Front façade faces east.
Modifications	<ul style="list-style-type: none"> • Weatherboard extension at the rear; • Window along south elevation has been replaced; • Glass panes along the east elevation have been replaced; • Garden wall along the east boundary has been replaced by a metal fence.

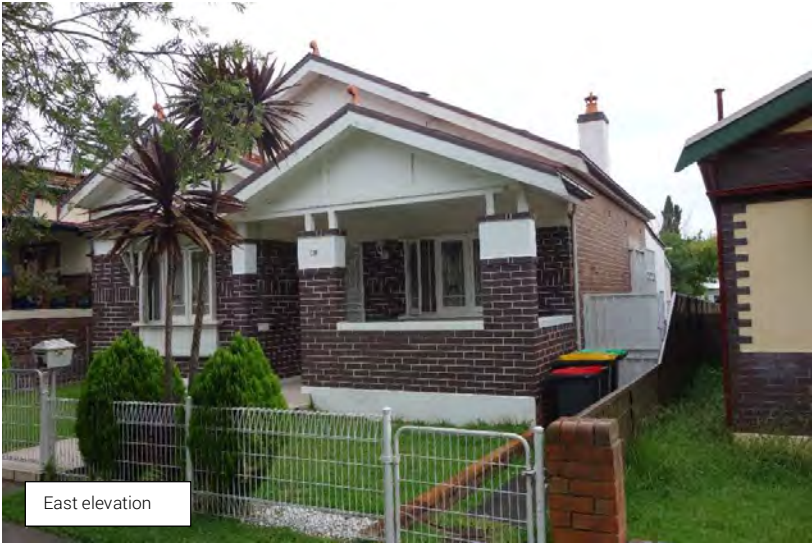
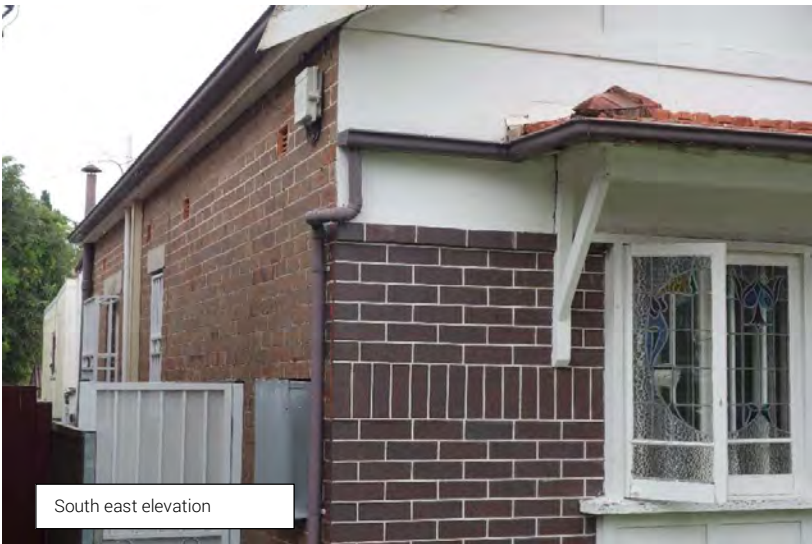
18 Cleary Avenue, Belmore

Description	Dwelling located on the western side of Cleary Avenue. Front façade faces east.
Modifications	<ul style="list-style-type: none"> • Fibre cement sheeting at the rear; • Awning along the east elevation has been replaced; • Garden wall along the east boundary has been replaced by a metal fence; • New brick work along the east elevation.

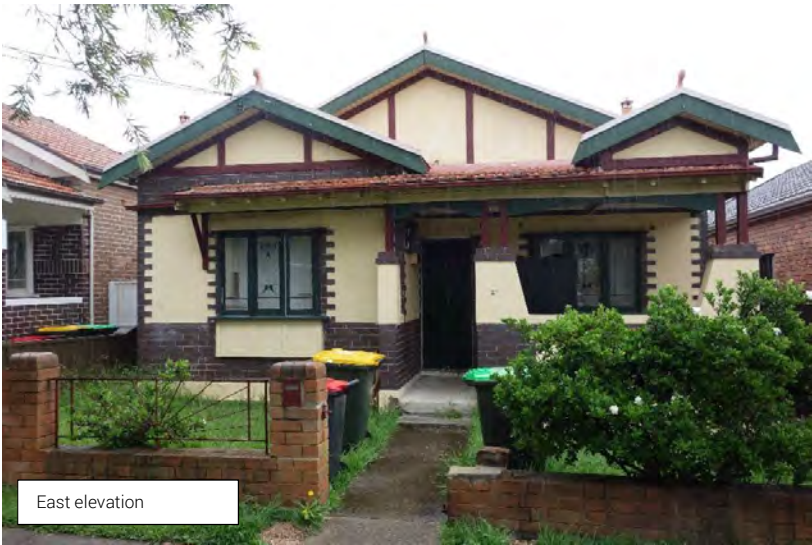
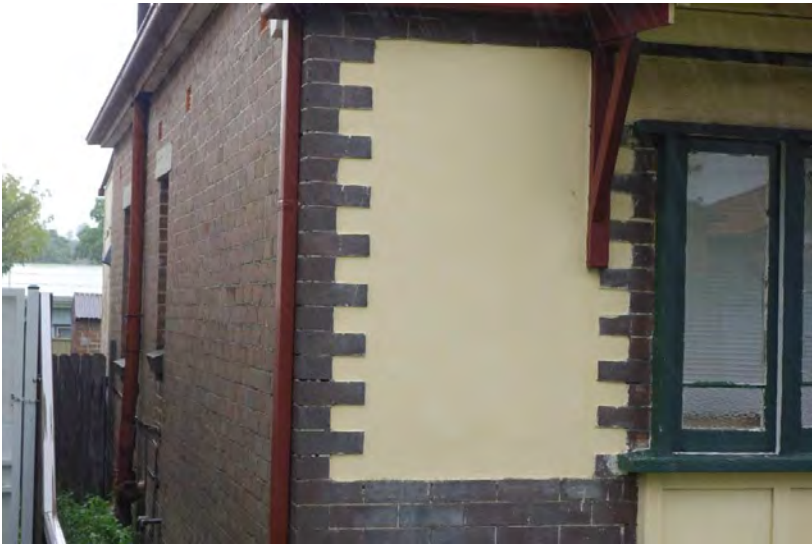
20 Cleary Avenue, Belmore

<p>Description</p>	<p>Dwelling located on the western side of Cleary Avenue. Front façade faces east.</p>
<p>Modifications</p>	<ul style="list-style-type: none"> • Window panes have been replaced along the east elevation; • Garden wall has been modified; • New paving

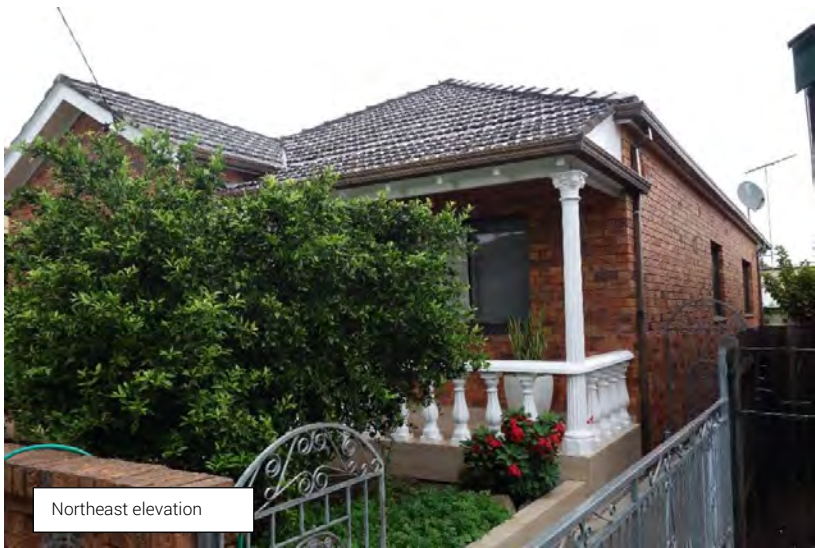
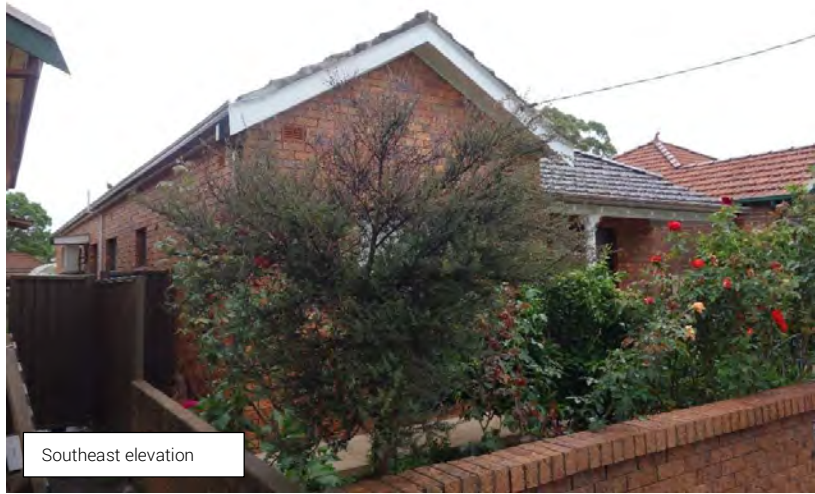
22 Cleary Avenue, Belmore

<p>Description</p>	<p>Dwelling located on the western side of Cleary Avenue. Front façade faces east.</p>
<p>Modifications</p>	<ul style="list-style-type: none"> • Dwelling has been heavily modified. • Air-con units along the south elevation; • Garden wall has been replaced

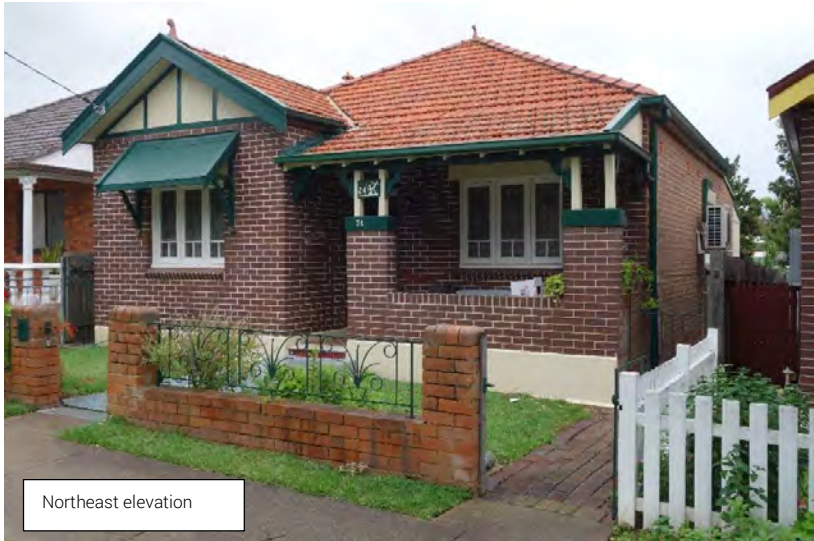
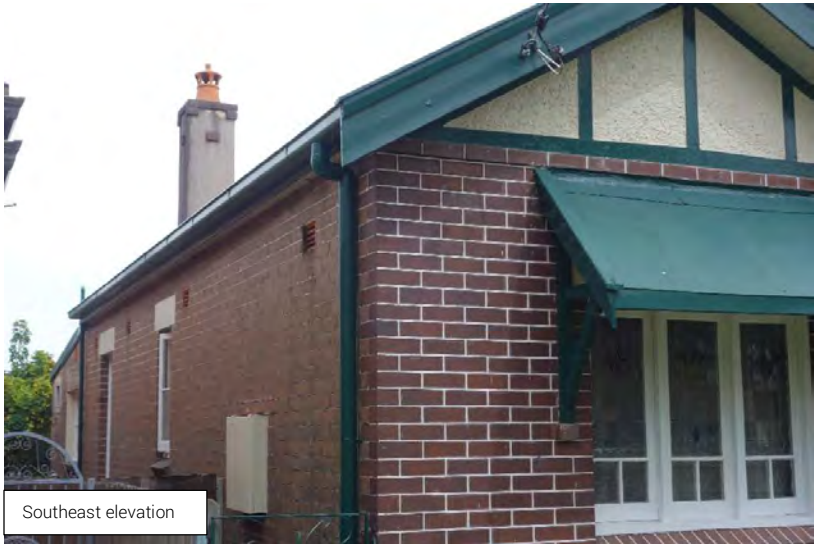
24 Cleary Avenue, Belmore

Description	Dwelling located on the western side of Cleary Avenue. Front façade faces east.
Modifications	<ul style="list-style-type: none"> • Brick extension at the rear; • New brickwork along the east elevation; • Garden wall has been modified; • Air-con unit along the north elevation.

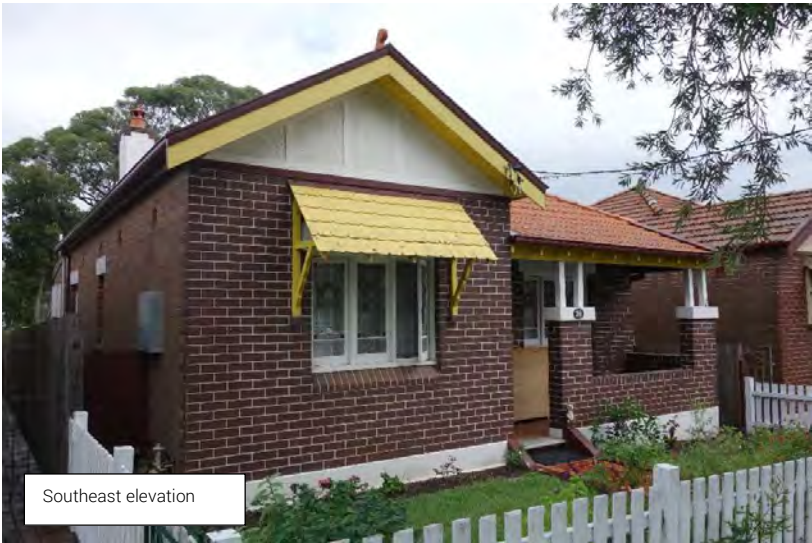
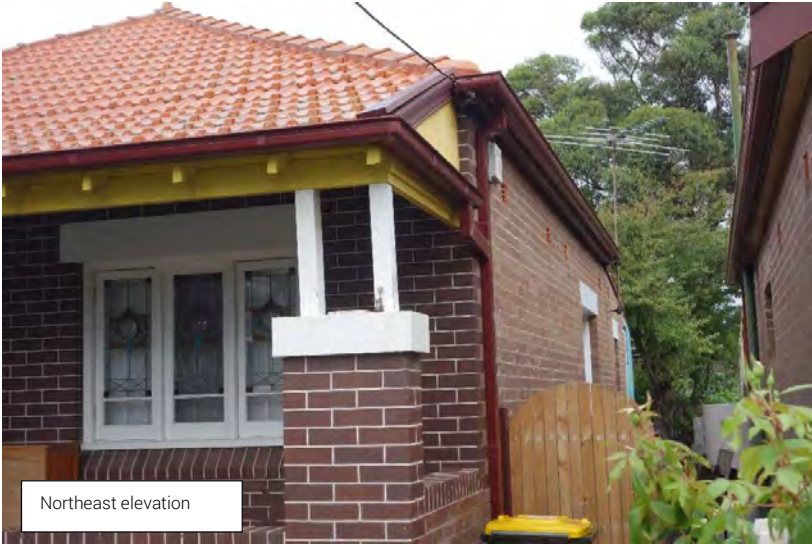
26 Cleary Avenue, Belmore

Description	Dwelling located on the western side of Cleary Avenue. Front façade faces east.
Modifications	<ul style="list-style-type: none"> • New brickwork along the east elevation; • Fibre cement sheeting extension at the rear; • Garden wall has been replaced

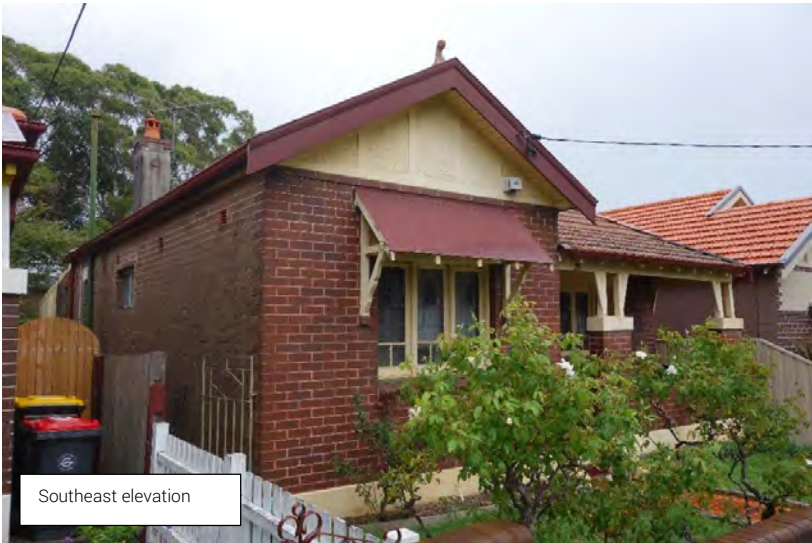
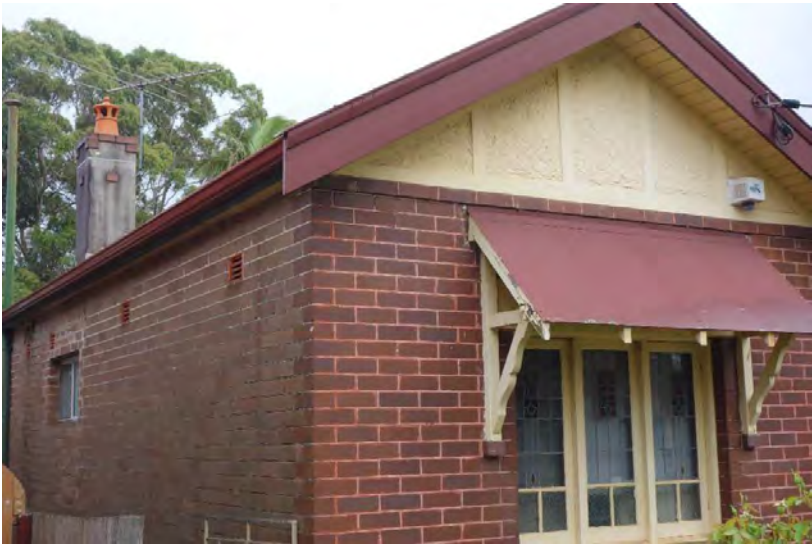
28 Cleary Avenue, Belmore

Description	Dwelling located on the western side of Cleary Avenue. Front façade faces east.
Modifications	<ul style="list-style-type: none"> • Window along the south elevation has been replaced; • Awning along the east elevation has been replaced; • Fibre cement sheeting extension at the rear.

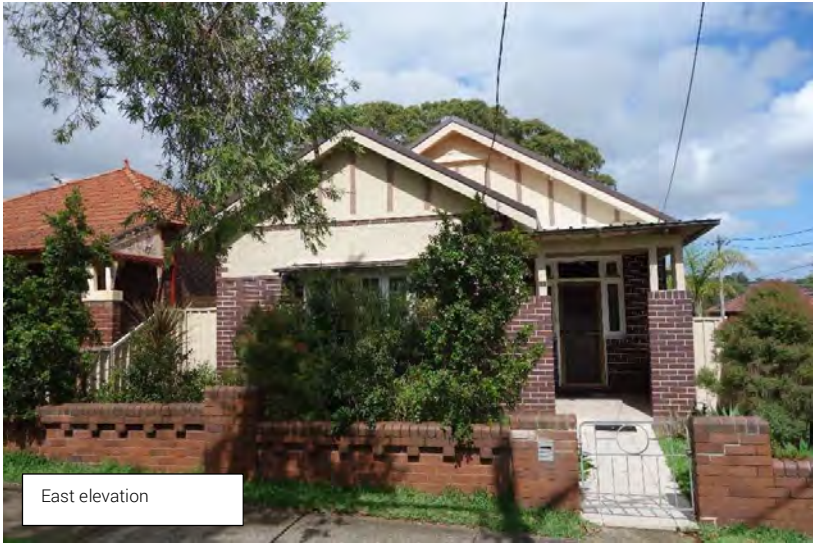
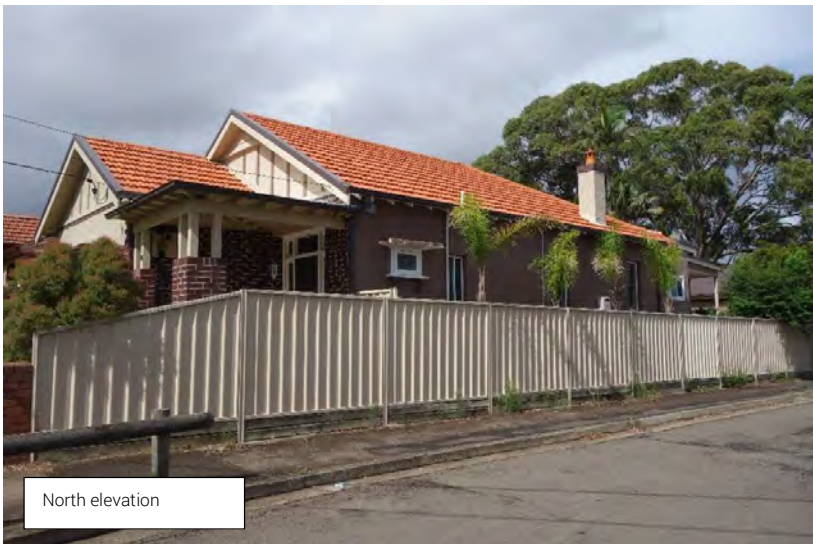
30 Cleary Avenue, Belmore

Description	Dwelling located on the western side of Cleary Avenue. Front façade faces east.
Modifications	<ul style="list-style-type: none"> • Brickwork along the north elevation has been rendered over; • New windows along the north elevation.

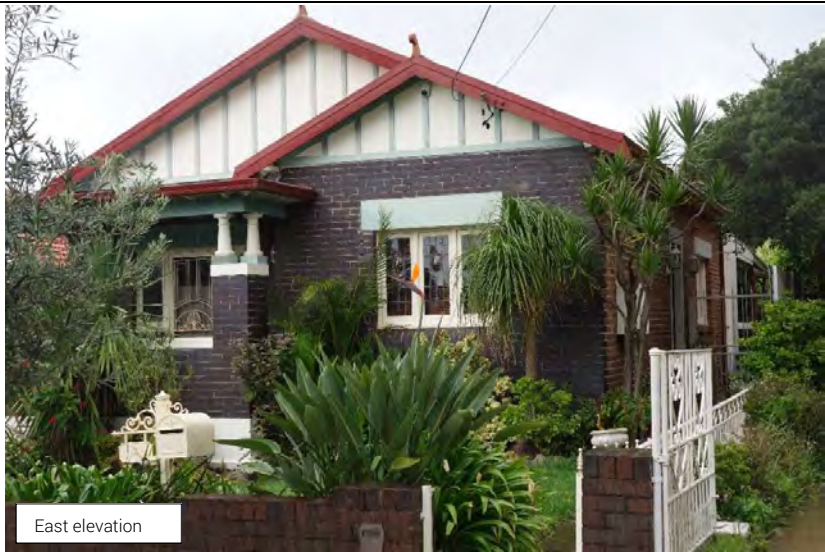
3 Acacia Street, Belmore

Location	Dwelling is located on the northwestern end of Acacia Street. Front façade faces east.
Modifications	<ul style="list-style-type: none">• Fibre cement sheeting lean to extension at the rear.

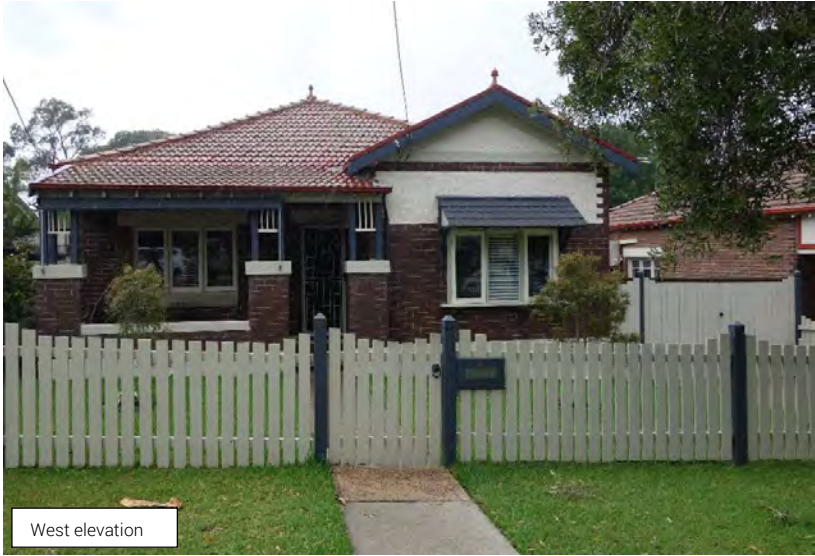
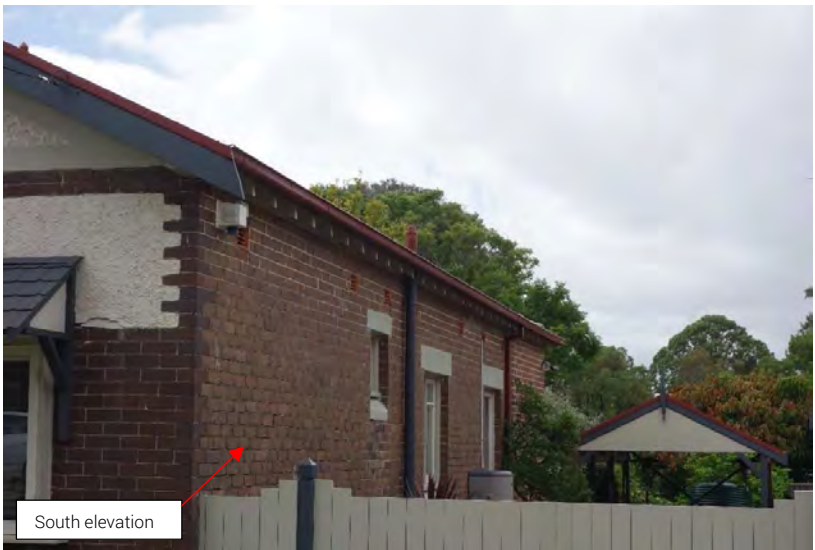
4 Acacia Street, Belmore

Location	Dwelling located on the eastern side of Acacia Street, front façade faces west.
Modifications	<ul style="list-style-type: none"> • Original window panes of the casement windows have been replaced along the front façade; • New brick extension at the rear • Carport and new paving to the south; • Air-conditioning unit on the north façade; • New timber picket fence.

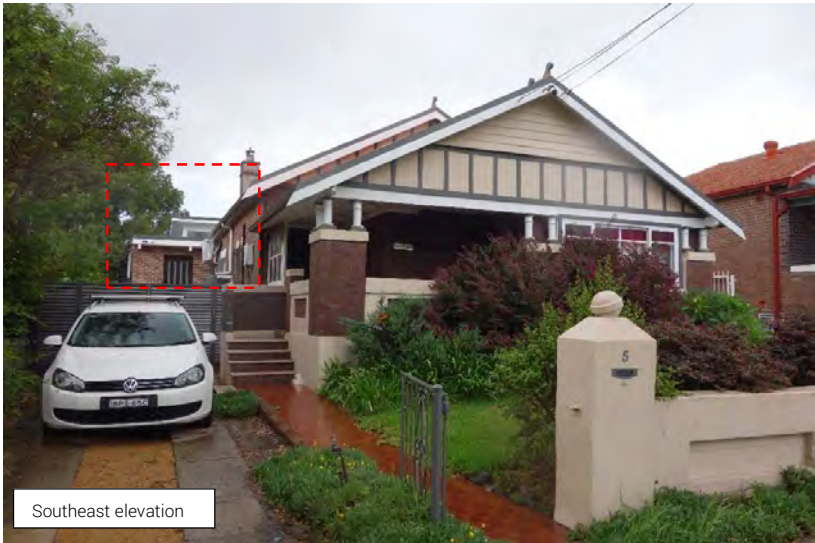
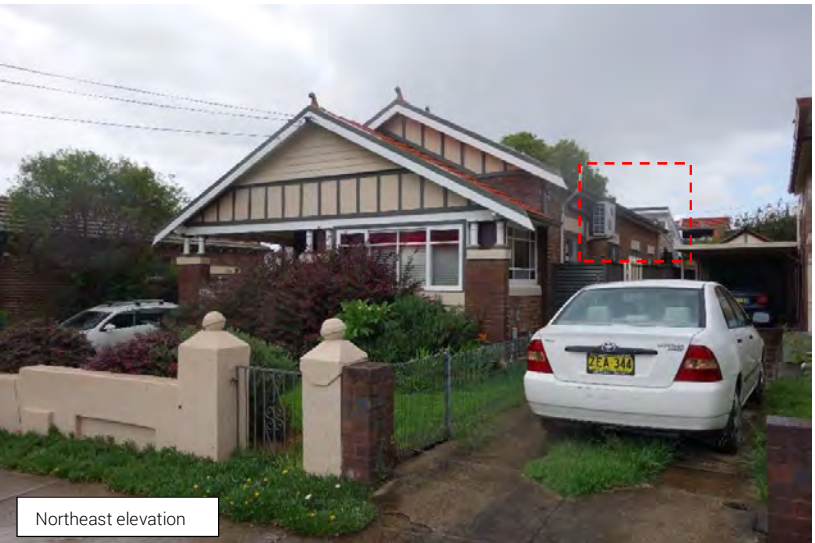
5 Acacia Street, Belmore

Location	Dwelling located on the western side of Acacia Street, front façade faces east.
Modifications	<ul style="list-style-type: none"> • Front facing façade window panes have been replaced; • Addition of air-con units on the north and south elevations; • Brick extension at the rear.

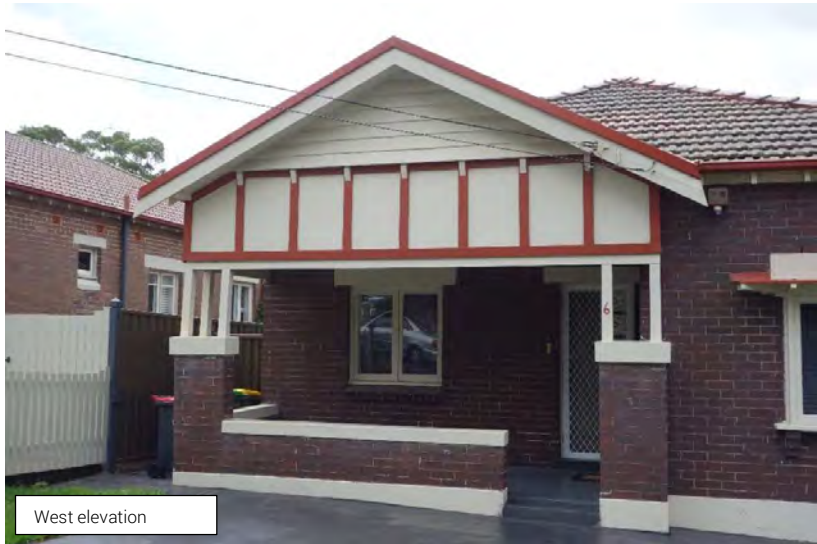
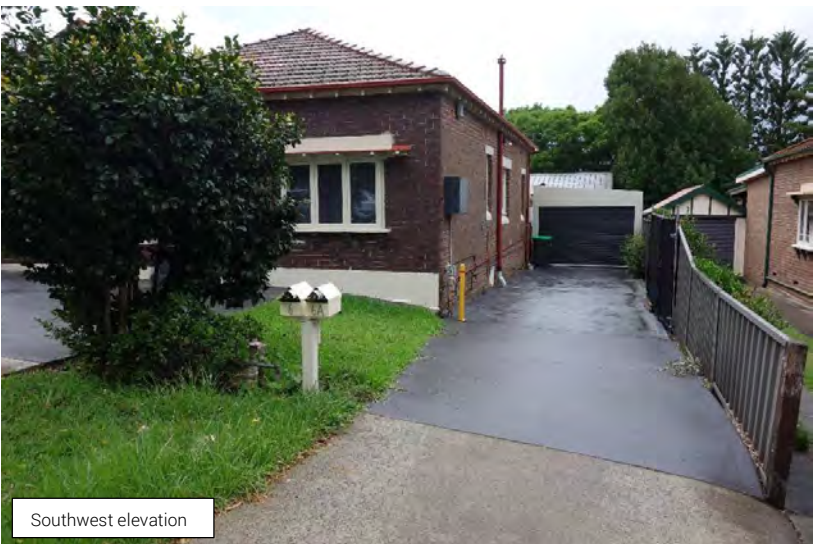
6 Acacia Street, Belmore & 6A Acacia Street, Belmore

Location	Dwelling located on the eastern side of Acacia Street. Front façade faces west.
Modifications	<ul style="list-style-type: none"> • Original window panes of the casement windows have been replaced along the front façade; • Gabled end detail has been replaced; • Addition of a garage at the rear for 6A Acacia Street, including new paving along the path and driveway; • The front garden wall has been removed;

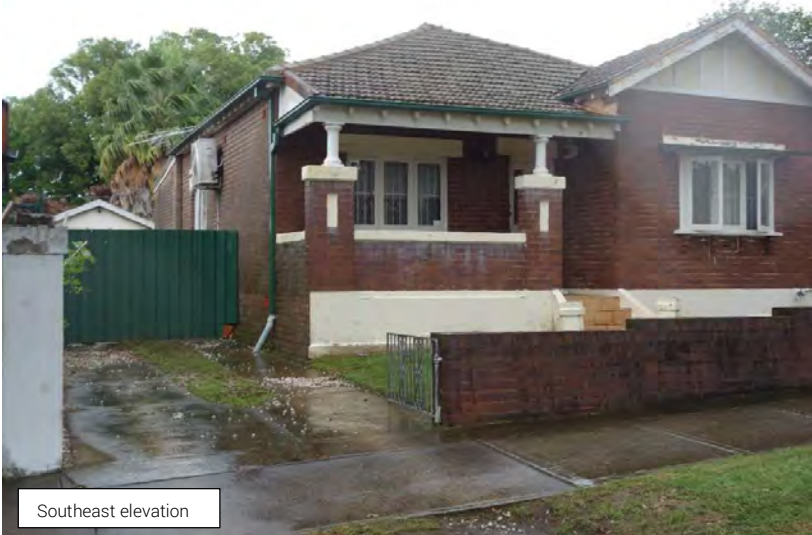
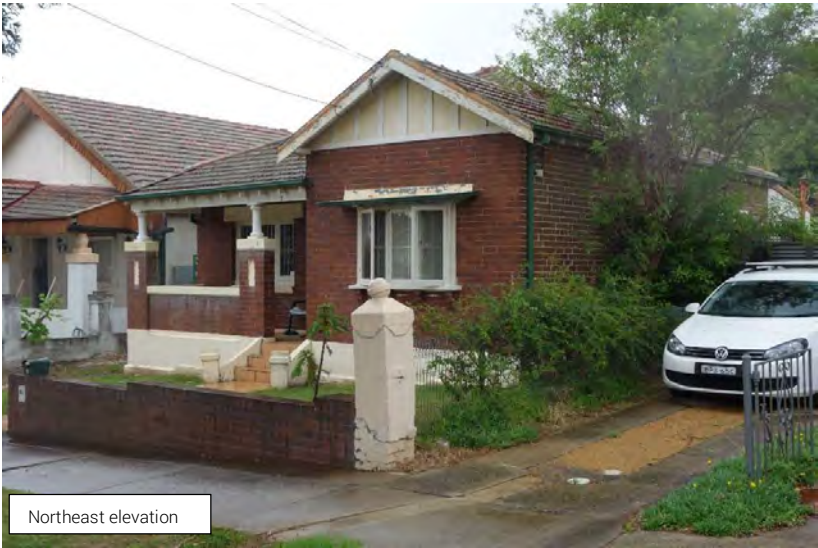
7 Acacia Street, Belmore

Location	Dwelling located on the western side of Acacia Street, front façade faces east.
Modifications	<ul style="list-style-type: none"> • East facing façade window panes have been replaced with clear glass. • Addition of a driveway and new paving; • Outbuilding at the rear.

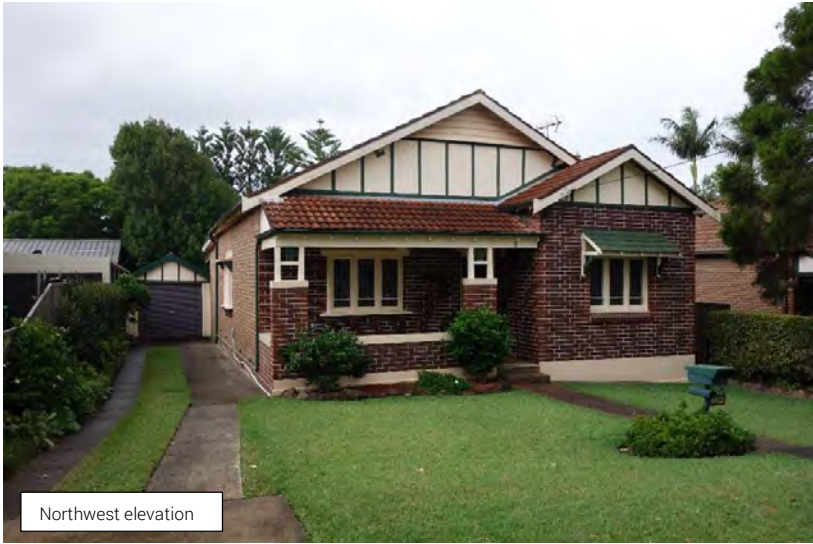
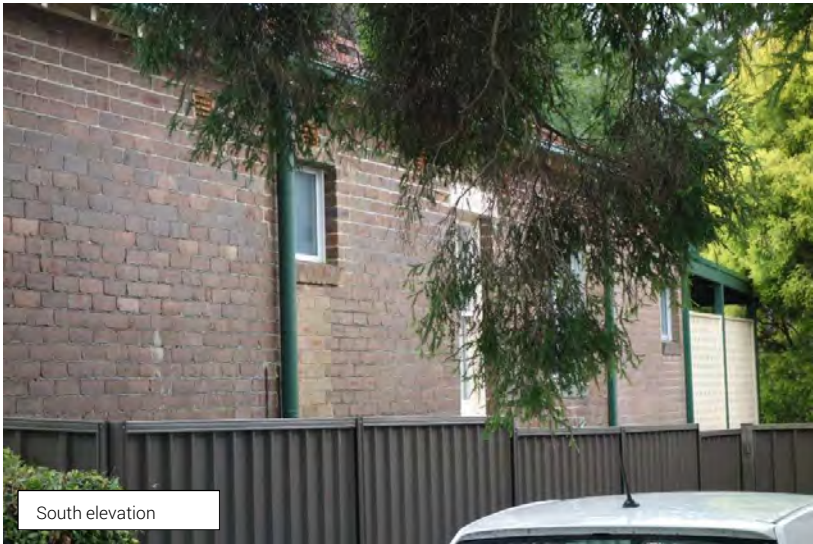
8 Acacia Street, Belmore

Location	Dwelling is located on the eastern side of Acacia Street, Front façade faces west.
Modifications	<ul style="list-style-type: none"> • Recent modifications to the front façade include brickwork and gable end detail; • Window openings have been infilled on the south facade • Later addition garage and driveway along the north elevation

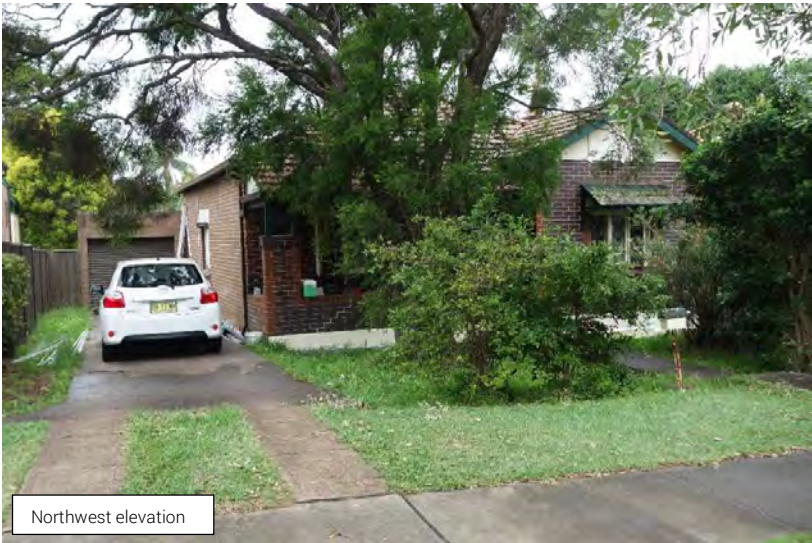
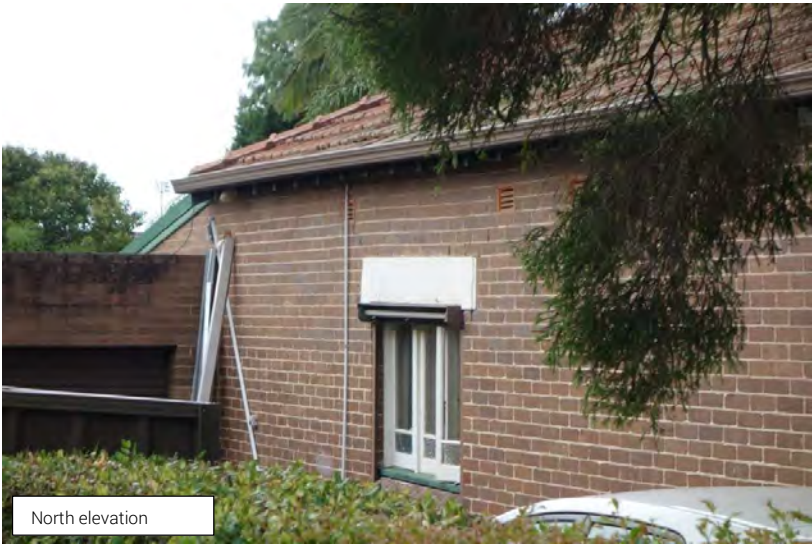
10 Acacia Street, Belmore

Location	Dwelling is located on the eastern side of Acacia Street. Front façade faces west.
Modifications	<ul style="list-style-type: none"> • Brick extension at the rear, as seen along the north façade; • Addition of a garage along the northern portion of the dwelling; • The front garden wall has been removed;

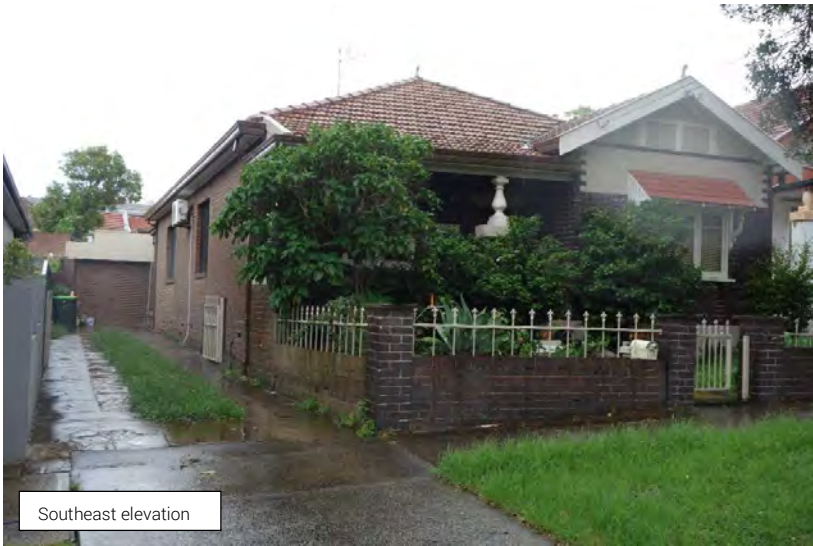
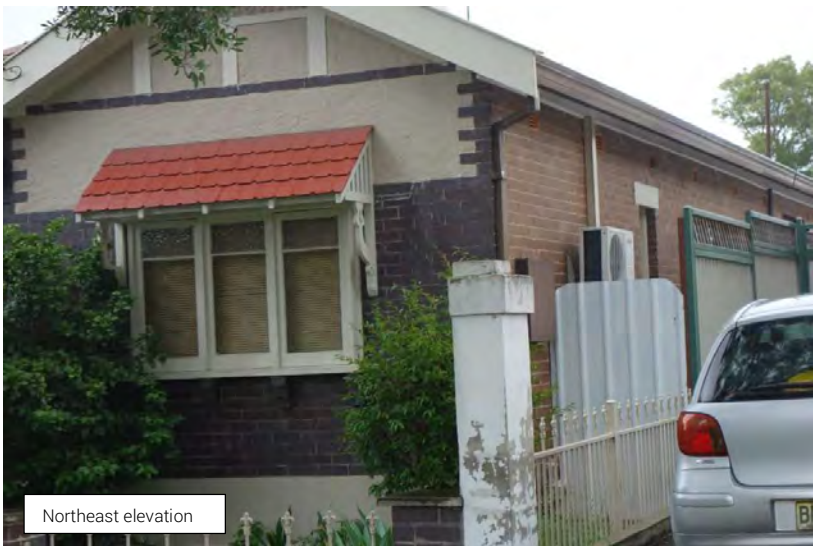
11A Acacia Street, Belmore

- New glass panes along the east façade facing Acacia Street;
- Air-con unit along the north and south elevations;
- Brick extension at the rear,

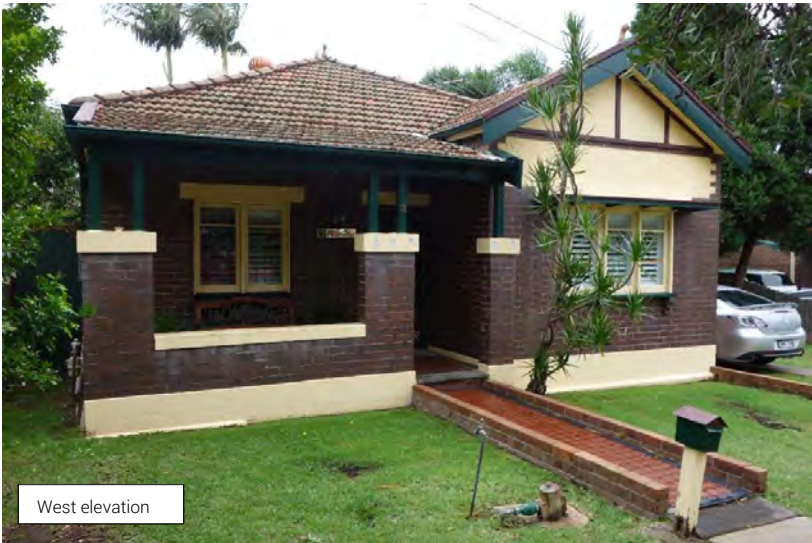
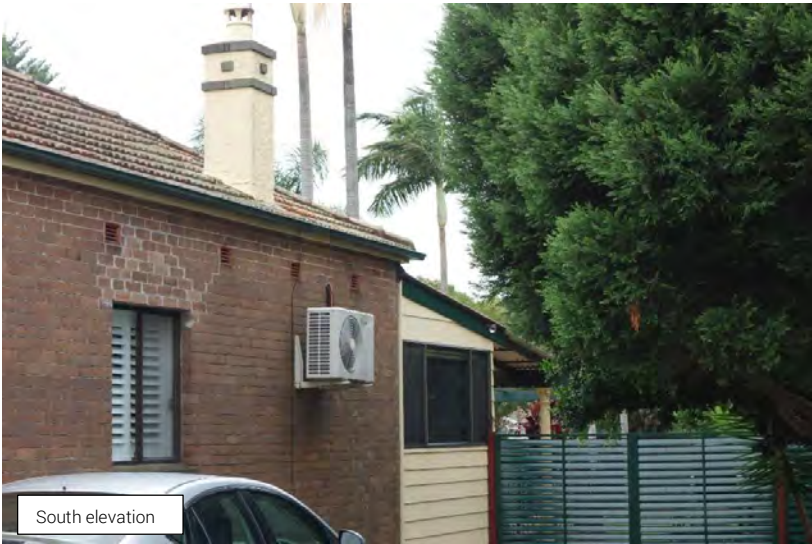
12 Acacia Street, Belmore

Location	Dwelling is located on the eastern side of Acacia Street, front façade faces west.
Modifications	<ul style="list-style-type: none"> • Weatherboard extension at the rear; • Modified brick work and new windows along the south façade; • Air-con unit along the south elevation; • Glass panes along the west elevation have been replaced; • Front yard modifications include removal of garden wall and modified front path.
