HERITAGE ASSESSMENT

Sydenham to Bankstown Urban Renewal Corridor
Heritage Review – Supplementary Review

20 May 2017

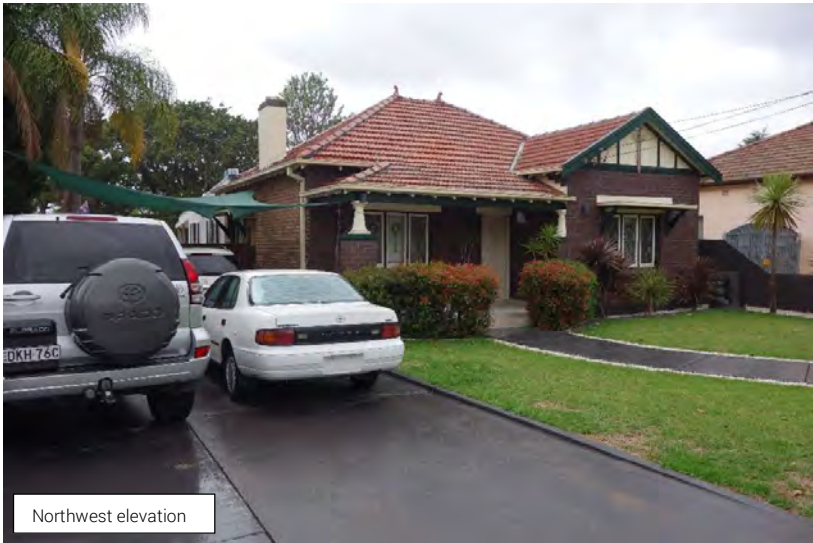
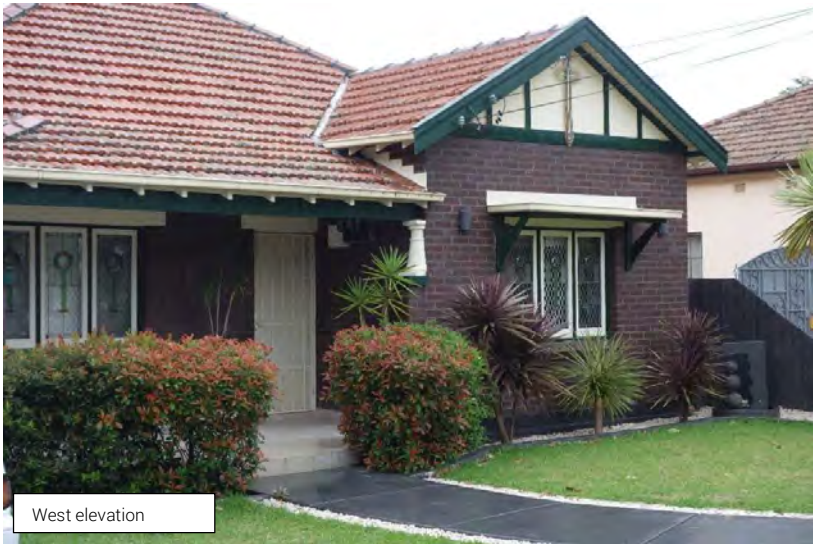
14 Acacia Street, Belmore

Location	Dwelling located on the eastern side of Acacia Street, front façade faces west
Modifications	<ul style="list-style-type: none"> • Front garden wall has been removed, and pathway has been repaved; • Driveway addition along the northern end of the site; • Fibre cement sheeting lean-to extension at the rear; • Chimney has been replaced/modified; • Air-con unit on the roof of the later extension at the rear; • Awnings along the west and north elevation has been replaced.

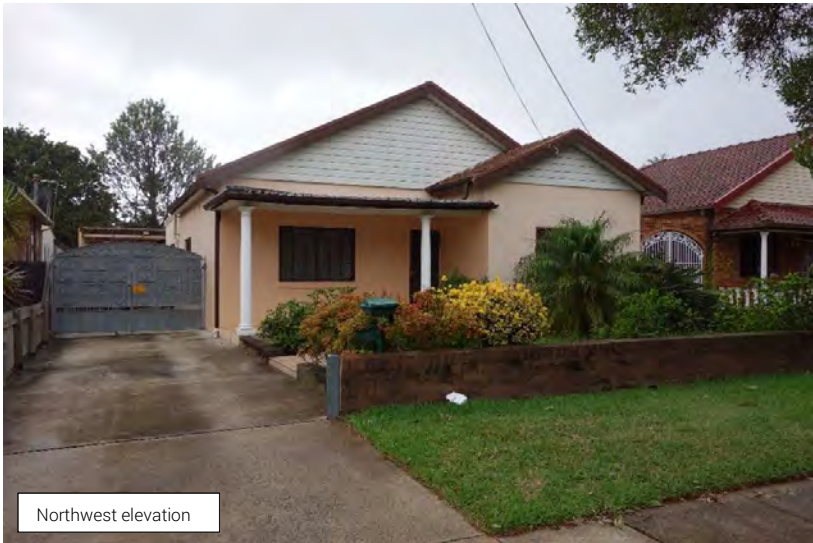
16 Acacia Street, Belmore

Dwelling located on the eastern side of Acacia Street, front façade faces west.

- Gable end detail has along the west elevation has been replaced/covered by timber panels;
- Windows along the west and north elevation have been replaced;
- Driveway extension along the northern side of the site;
- Fibre cement sheeting extension seen at the rear.

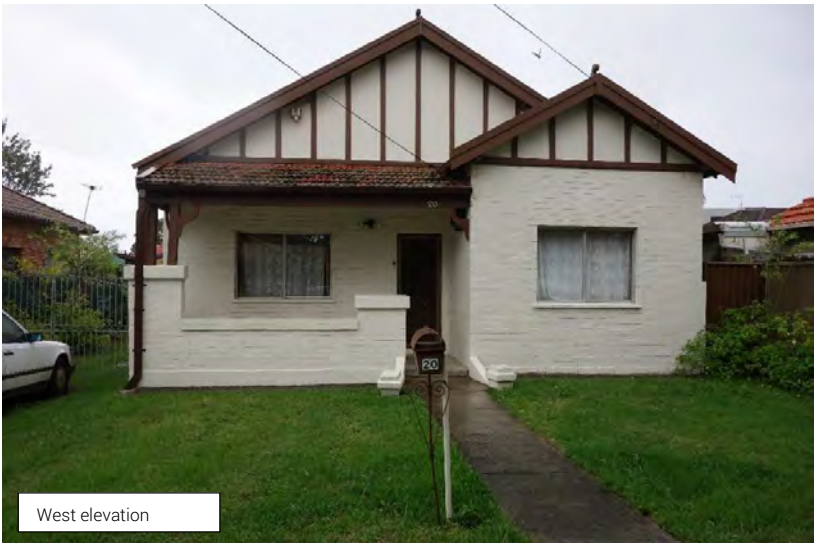
20 Acacia Street, Belmore

<p>West elevation</p>
Location	Dwelling located on the eastern side of Acacia Street, front façade faces west.
Modifications	<ul style="list-style-type: none"> • Windows have been replaced; • Front garden wall has been removed.

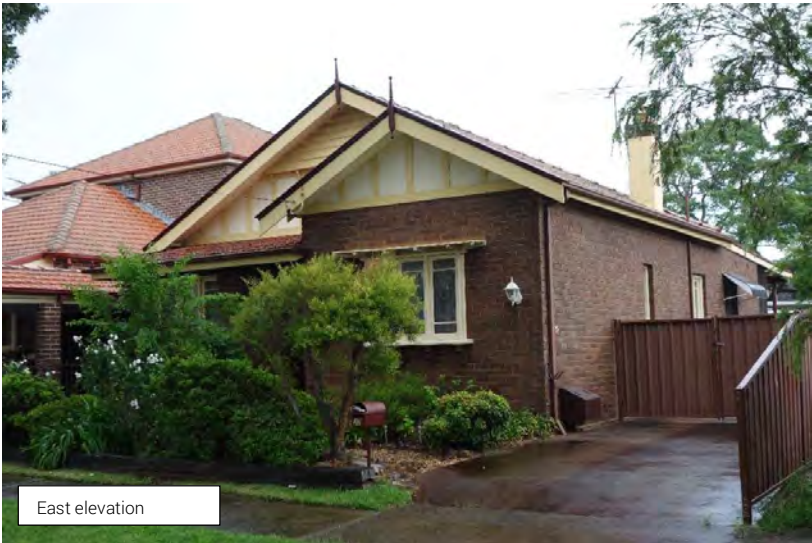
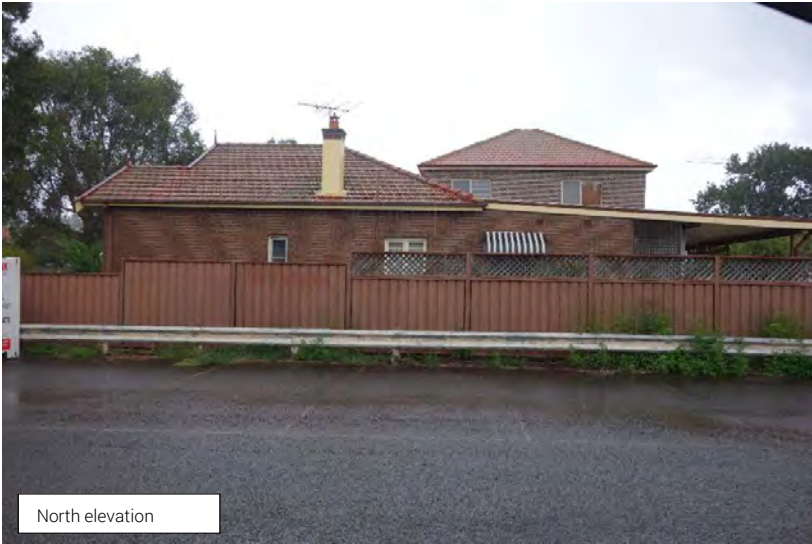
21 Acacia Street, Belmore

Location	Dwelling located on the western side of Acacia Street, front façade faces east.
Modifications	<ul style="list-style-type: none">• Brick extension and verandah at the rear;• Modified gabled end detail;• Addition of a driveway and paving.
